# Manhole Inspection Summary

Manhole # S27M\_\_003MH

Insp Date: **5/5/08 9:35 AM**

**Location** Address: **1222 W Ostend St**

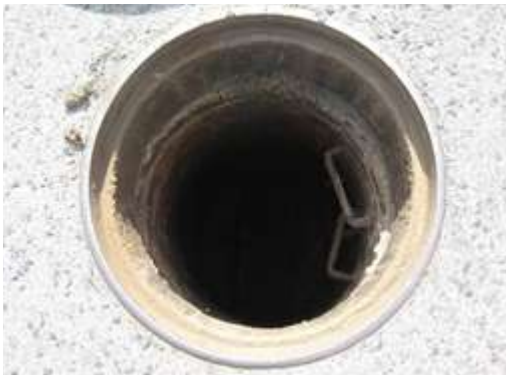
MISCELLANEOUS

Comments **The MH is constucted in a way that a 10inch pipe is tapped in the main 22inch line see pics, 6oclock pipe is tapped in the 22inch line that is located at 5oclock it looks like one pipe but two are connected**

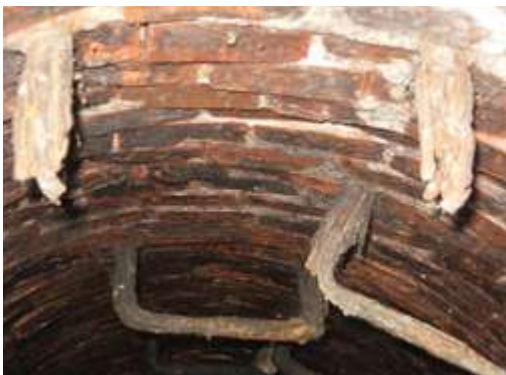
Defect 5

Count: **10** Missing: **2** ☒ **Corroded**

MISSING RUNG

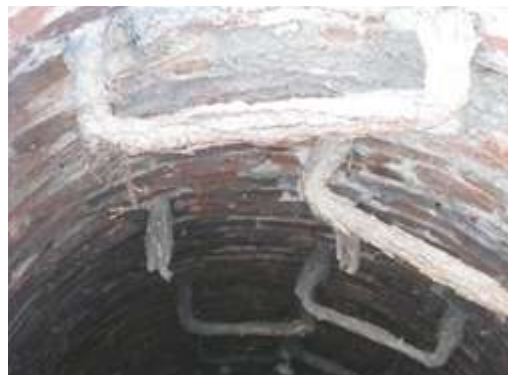
Defect 4

Condition: ☒ Sound ☐ Cracked ☐ Root Intrusion ☐ Loose Brick ☒ **Deteriorated**

RUSTED RUNGS,MISSING MORTAR,  
CHIPED BRICKS IN CORBEL

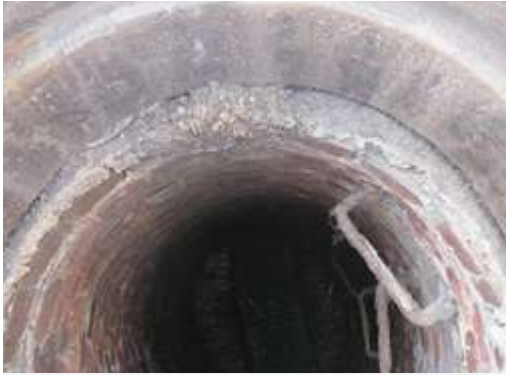
Defect 3

Offset: **1.5** (in.)

OFFSET 1.5

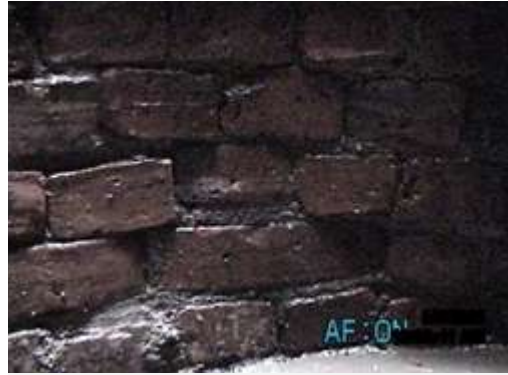
Defect 2

Infiltration: ☐ None ☐ Joint ☐ Cracks ☐ Mortar ☐ Roots ☒ **Wall**

SIGNS OF INFILTRATION IN BARREL

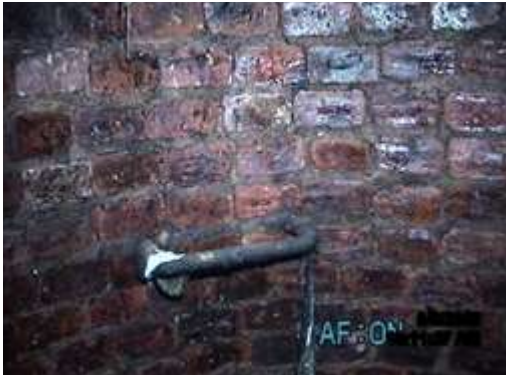
Defect 1

☒ **Evidence Of Surcharge** Depth: **2.5** (ft.) ☐ Active Surcharge Present

SIGNS OF SURCHARGE

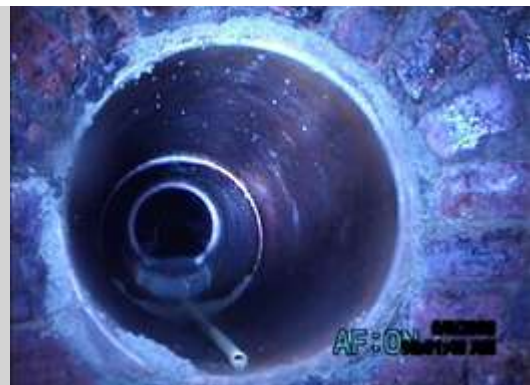
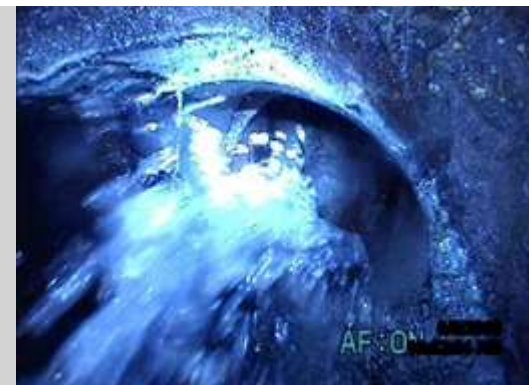
6 O'Clock Inflow

12 in. Circular Gravity Sewer  
Pipe In @ 6 OClock

Drop: **Outside** Rod and Bar
